SERVICE BULLETIN No.159

E-60 and E-60H QuikLift® Units

HIGH OPERATING PRESSURE

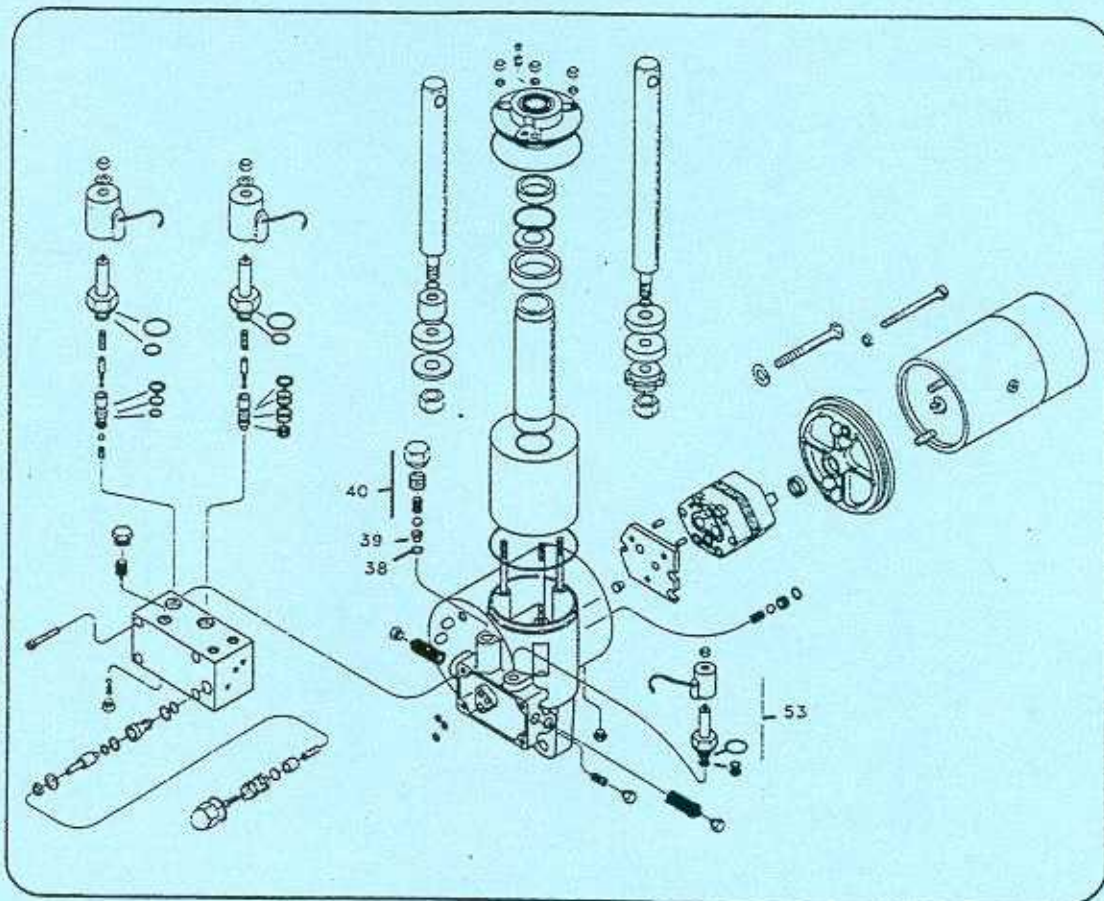
Reports from the field have indicated that some E-60 and E-60H hydraulic units are developing high pressure due to a loose BALL SEAT item 39 beneath the Pressure Relief Valve Assembly item 40. Among the symptoms of high operating pressure are a No lower situation or Breaking of the Top Cap Assembly Part number 15738. If the Ball Seat is found to be loose, remove the Ball seat and inspect the O-ring for damage. Reinstall Ball Seat and torque to 100 inch pounds. Reset the operating pressure to 2500 P.S.I. **IMPORTANT:** Operating pressure should be checked after the Pressure Relief Cap Nut has been assembled.

Inspection of the Ball Seat should be made prior to delivery on New Installations and over the counter sales.
